Monday, January 21, 2010

Client: John & Janet Doe

1234 Main Street

Inspector: Randy Howland

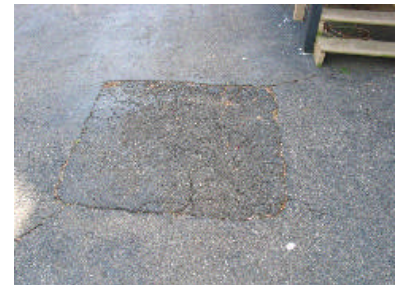
TYPE: Asphalt.
CONDITION: Previous sealing maintenance was noted at the driveway. The driveway surface has some patched and repaired areas. Some additional sealing and repairs, to the driveway surface, is recommended.

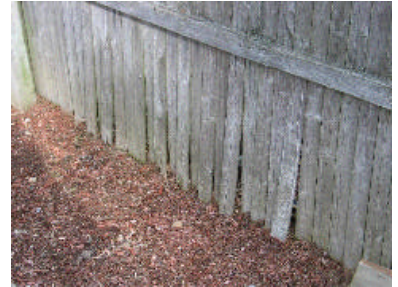
TYPE: Wood.
CONDITION: Portions of the fence surfaces are in disrepair. Loose and damaged boards were noted. We recommend that a qualified fence contractor evaluate further and repair or replace as needed.

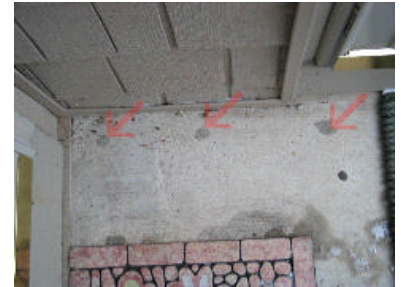
There was evidence of a previous termite treatment. Inquiring Eye Home Inspections is not licensed, and does not perform wood destroying insect inspections. There is no warranty or information on the treatment provided or the extent of the damage that may have occurred. Due to the nature of termite, or other wood destroying insect damage we are unable to confirm if internal damage, to the structure, may be present.

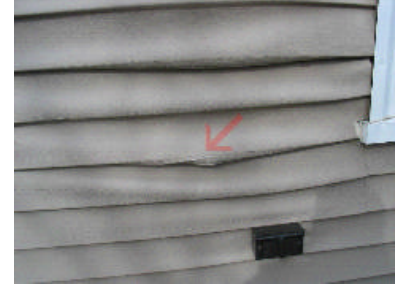
LOCATION: House.
MATERIAL: Vinyl siding.
CONDITION: Damaged areas of siding were noted. We recommend having a qualified, licensed building contractor evaluate further and make repairs as needed.

The current siding is vinyl. This is not the original siding. We are unable to provide you with additional information about the original siding or its current condition. Conditions may exist, such as wood rot, damage, or wood destroying insects that were not visible and are unable to be determined.

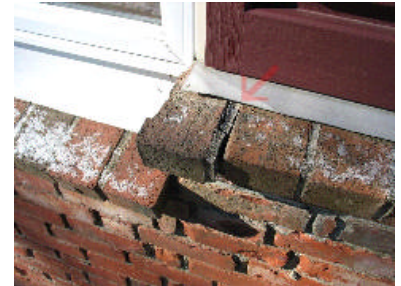
LOCATION: House.
MATERIAL: Brick.
CONDITION: Loose and damaged areas of brick work were noted. We recommend having a qualified, licensed, masonry contractor evaluate further and make repairs as needed.

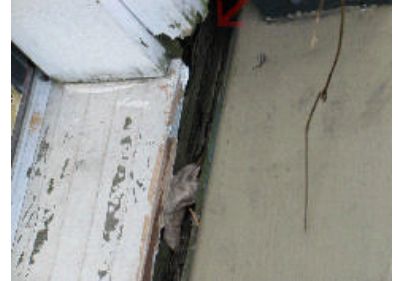
CONDITION: Damage was viewed at the front doors framing at/to the house. Rot and decay were noted. A licensed building contractor should evaluate the doors further and repair or replace as needed.

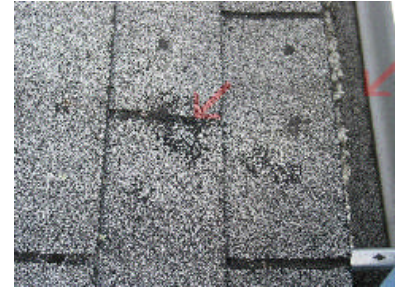
LOCATION: House.
STYLE: Gable.
ACCESS: The inspector walked the roof.
TYPE: Single laminate asphalt shingles, design life 20 years +/-.
APPROXIMATE AGE: 18 to 20 Years Old +/-.
CONDITION: Loss of shingle particulate was noted. Spreading, shrinkage of the shingle surfaces, caused by advanced aging, was noted at portions of the roof surfaces.

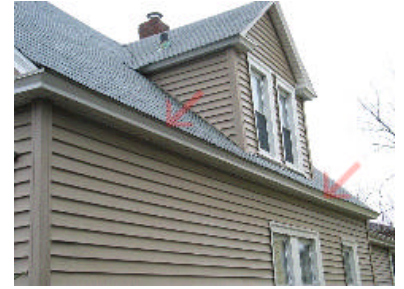
No gutters were present at portions of the right side of the house. We recommend installing a gutter system to direct water runoff away from the foundation. Water that deposits at the building foundation can potentially enter the lower levels of the house, and place undue pressure on the buildings foundation. All rain leaders should terminate as far away from the building as possible. We recommend having a licensed gutter contractor evaluate further and install or repair as needed.
